**TECHNICAL REPORT  
TR-NAVFAC-EXWC-EV-1510  
MAY 2015**

**MODELING & VERIFYING AIRCRAFT PAINT  
HANGAR AIRFLOW TO REDUCE GREEN HOUSE GAS  
AND ENERGY USAGE WHILE PROTECTING  
OCCUPATIONAL HEALTH**

**Edwin Chiang P.E.  
NAVFAC EXWC**

**James S. Bennett Ph.D.  
NIOSH**

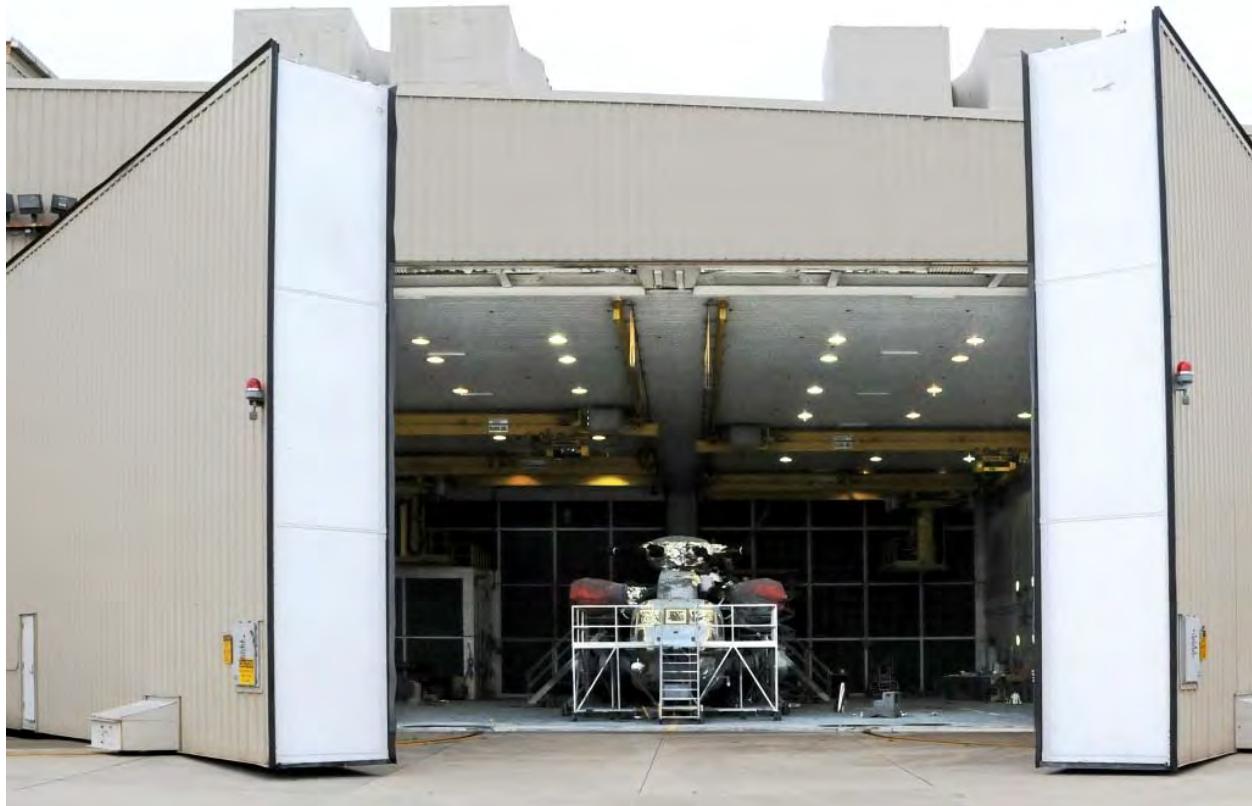
During the initial walkthrough of the cross flow hangar (Figure 7), the team observed that only 2 out of 4 supply fans and 6 out of 8 exhaust fans were operational. Maintenance and repair of the system was discussed with site engineers, and funding for the extensive repairs needed was identified as a large issue.

**Figure 7: View of the MCAS Cherry Point Helicopter Painting Hangar.**

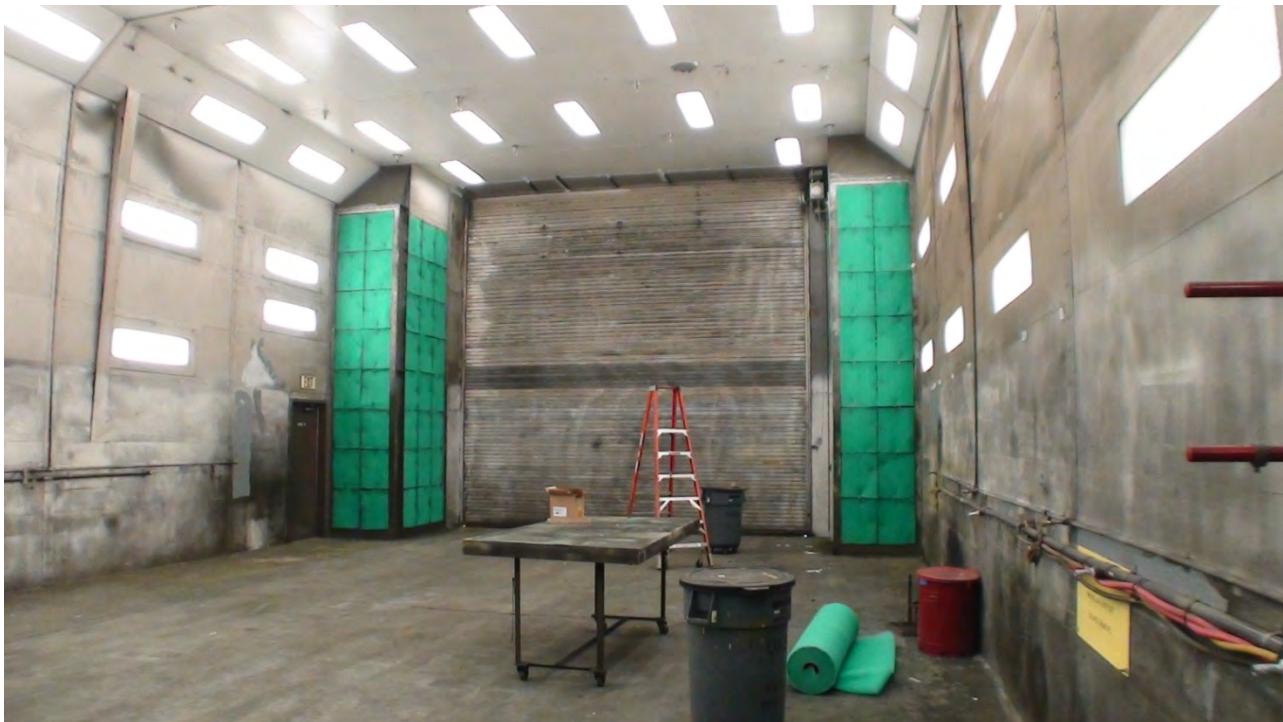
During the site visit, NIOSH researchers were able to observe an annual ventilation certification test conducted by Robert Anderson, an Army industrial hygienist. A smoke candle was used to observe the flow pattern in the hangar. The test suggested effective directional flow from the supply end to the exhaust end, with relatively little turbulence.

Figure 11: The Fort Lewis helicopter painting hangar. The exhaust filter columns can be seen on either side of the hangar door.
